Re: 2019 Willow Lake Dam Inspection Report
WHA No. 1152R19

Willow Lake Dam
Dam Inventory No. 01205
Permit Number DS2001048
Class 1 (Small)

ANNUAL DAM INSPECTION REPORT

WILLOW LAKE ASSOCIATION
FREEPORT, IL

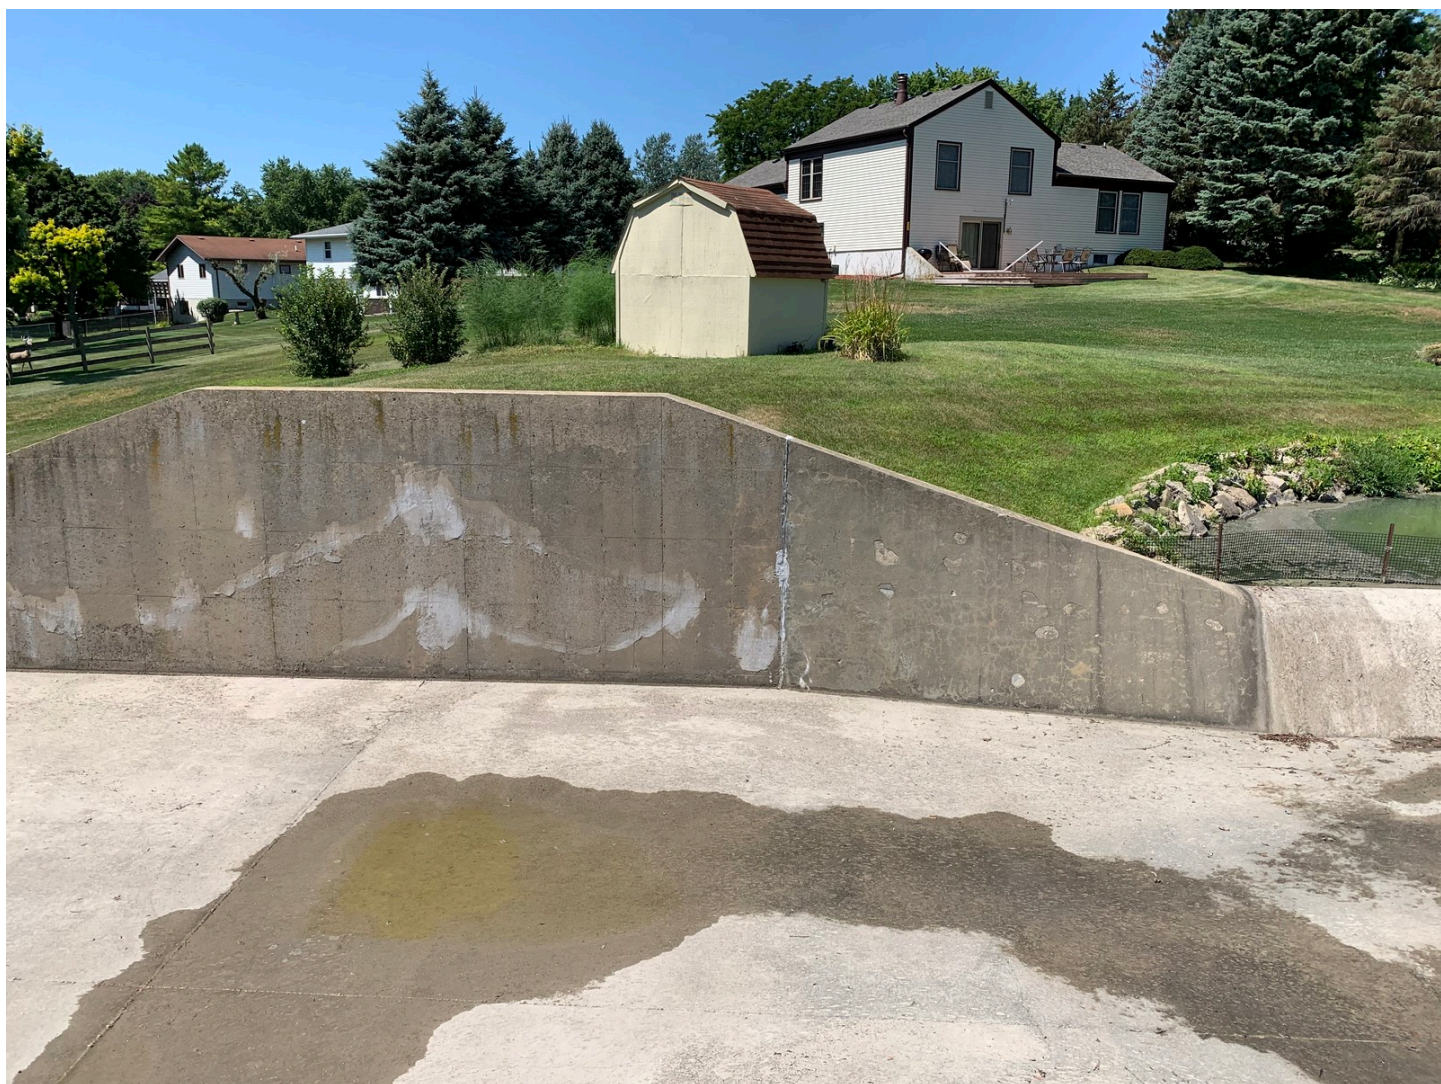
Photo #1 – West emergency spillway wall. Good condition.

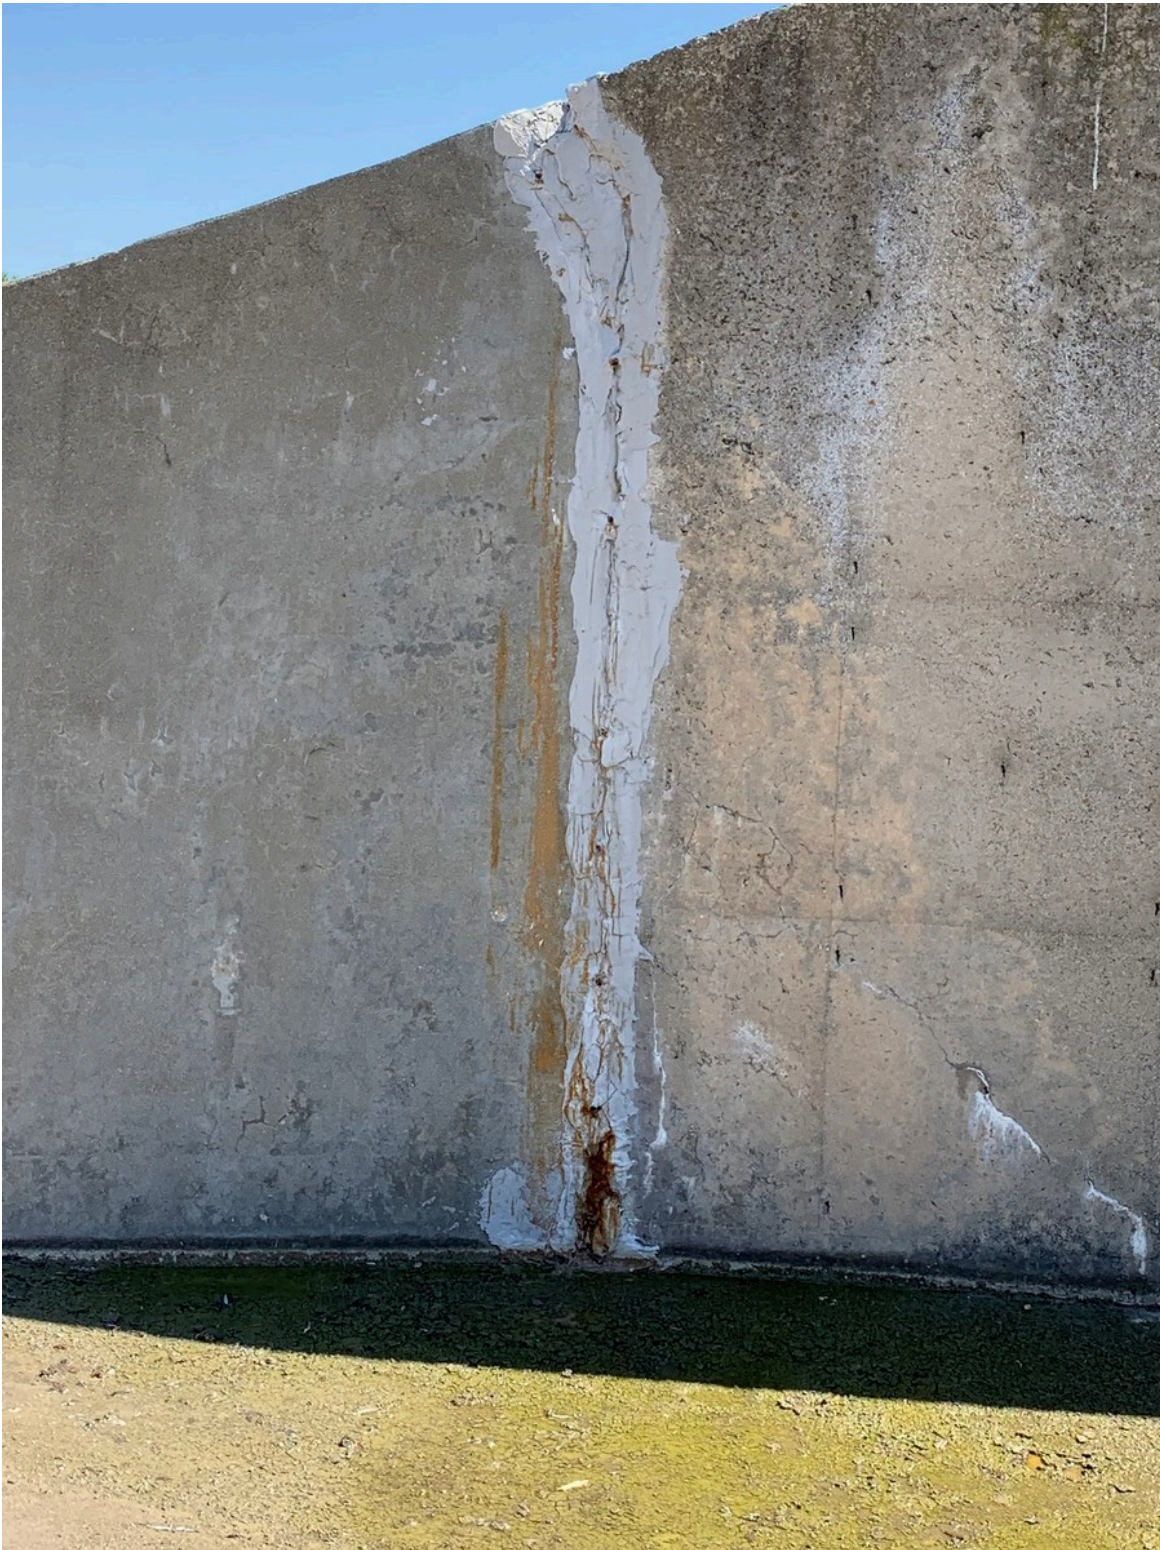
Photo #2 – East emergency spillway wall. Repaired joint, good condition.

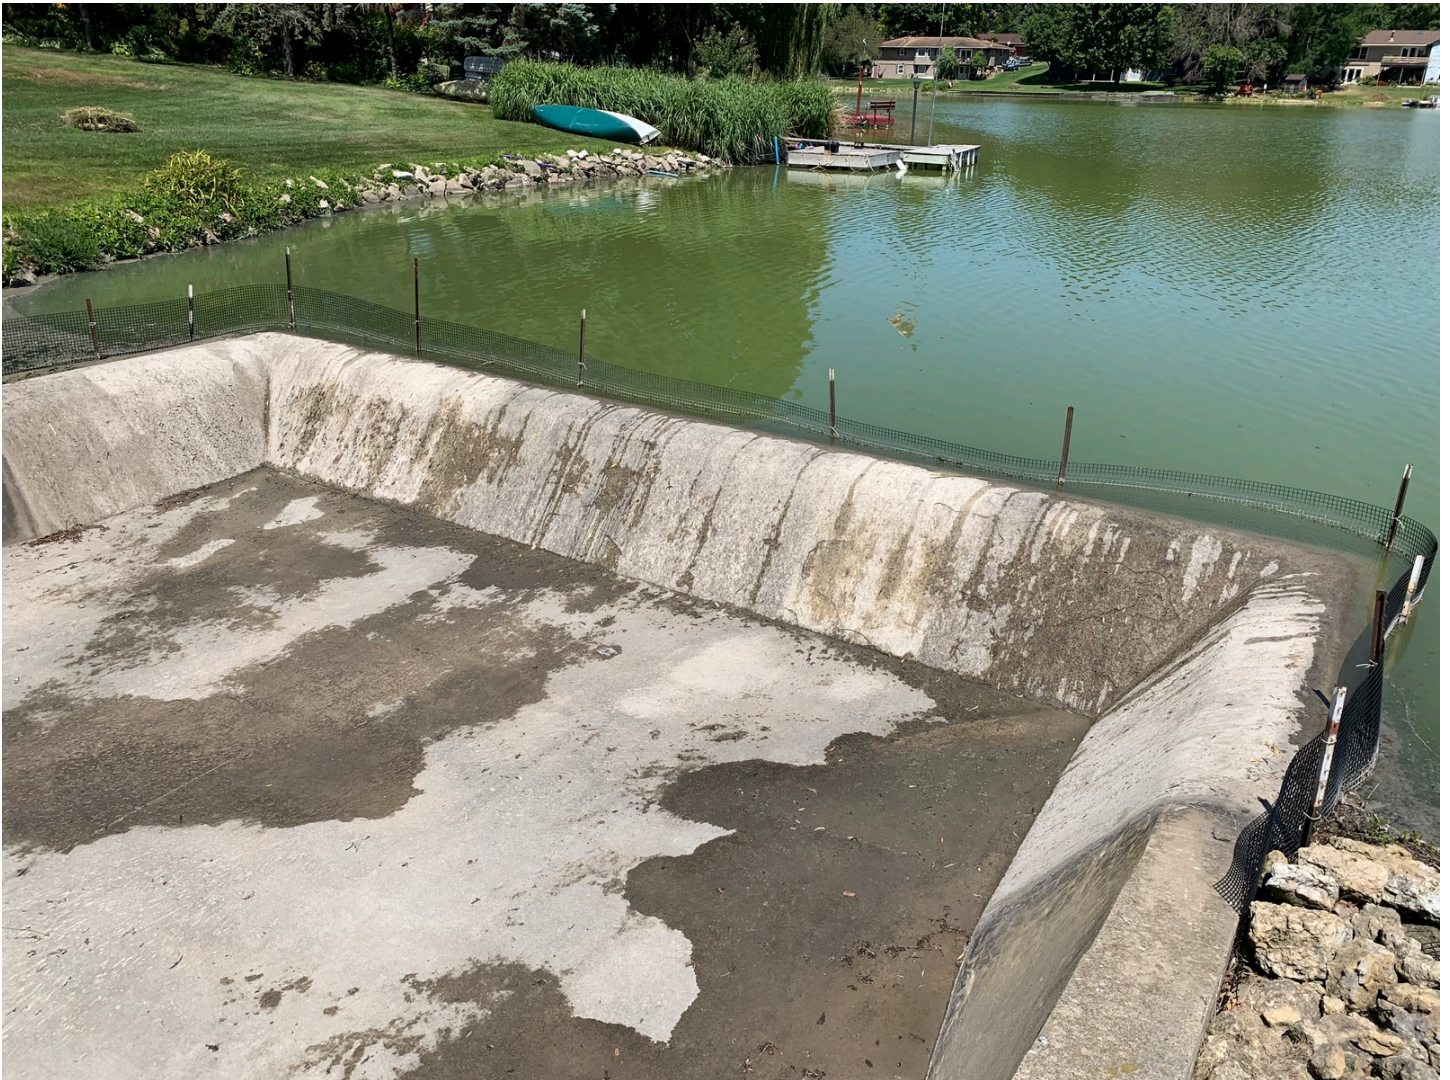
Photo #3 – Inlet side of emergency spillway. Good condition.

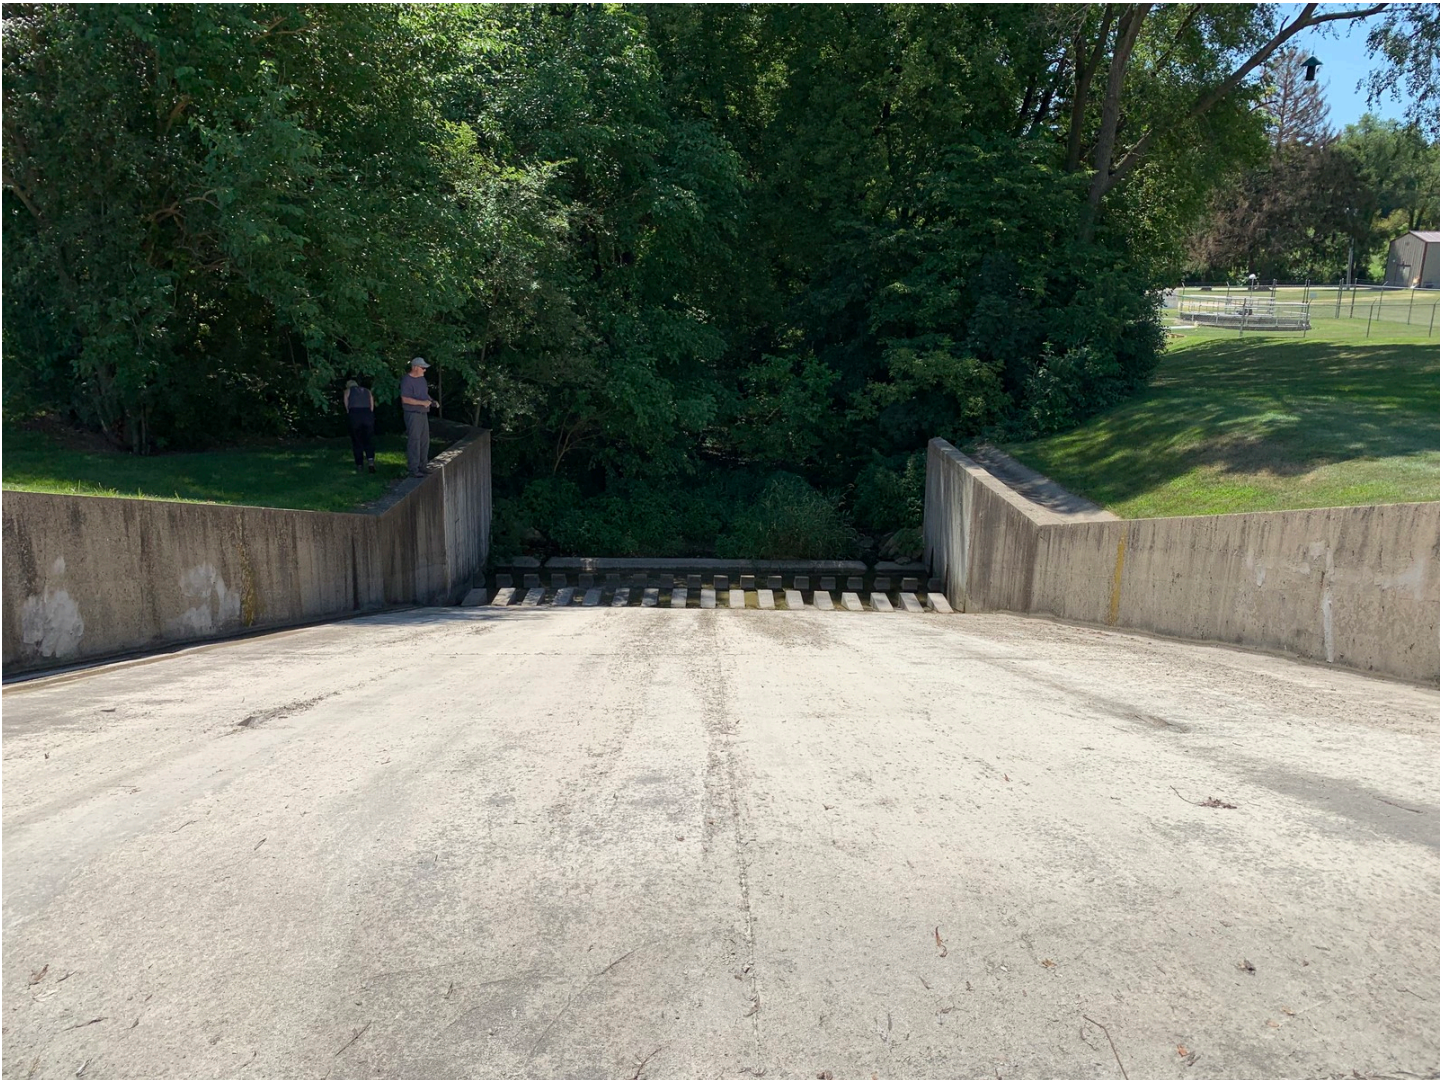
Photo #4 – Downstream end of emergency spillway. Good Condition.

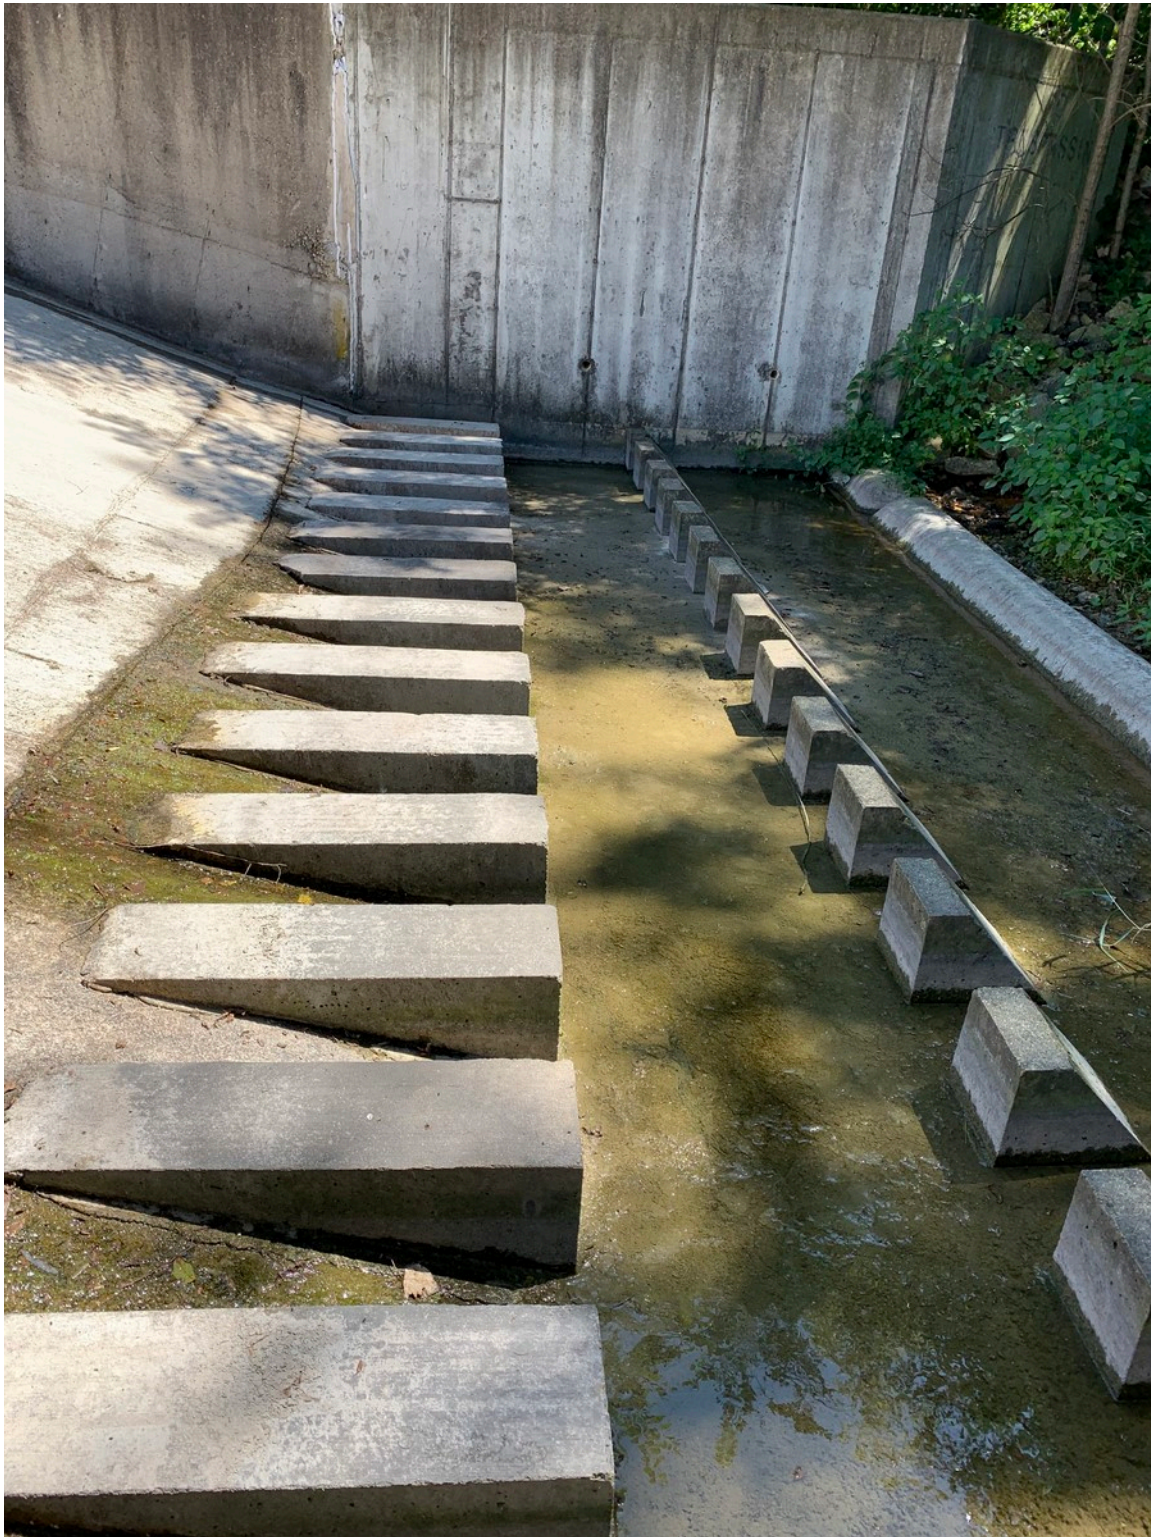
ITEM	CONDITION CODE	DEFICIENCIES	RECOMMENDED REMEDIAL MEASURES AND IMPLEMENTATION SCHEDULE
Erosion	NE		
Weeds, Logs, Other Obstructions	NE		
Side Slope Sloughing	NE		
Vegetation	NE		
Sedimentation	NE		
Riprap	NA		
Settlement of Crest	NE		
Downstream Channel	MM	Tall grass and small tree in outlet channel. Tree should be removed.	Remove Tree
Other	MM	Minor leak in joint between energy dissipator and main chute wall - west wall.	Note: Weeps also active No Issues on East
Other	MM	Active seepage continues at slab joint between chute and dissipator - All from natural spring

Photo #5 – Emergency spillway energy dissipator. Minor seepage from spring at slab joint.

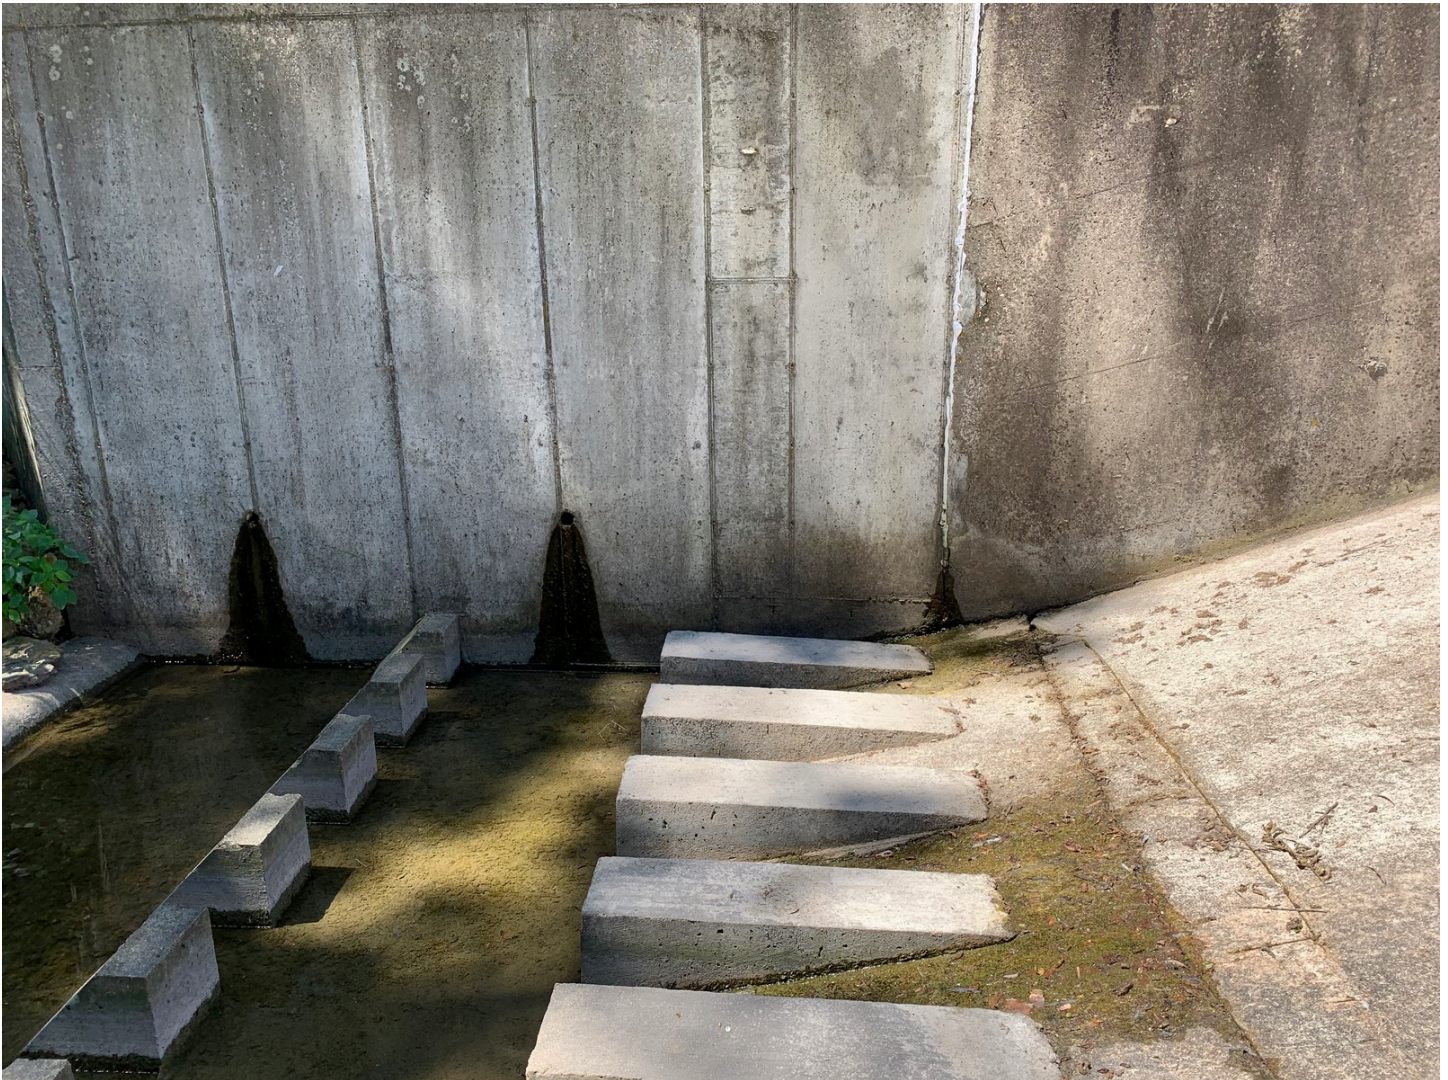
Photo #6 – Minor seepage from spring at bottom of wall joint and active weep holes.

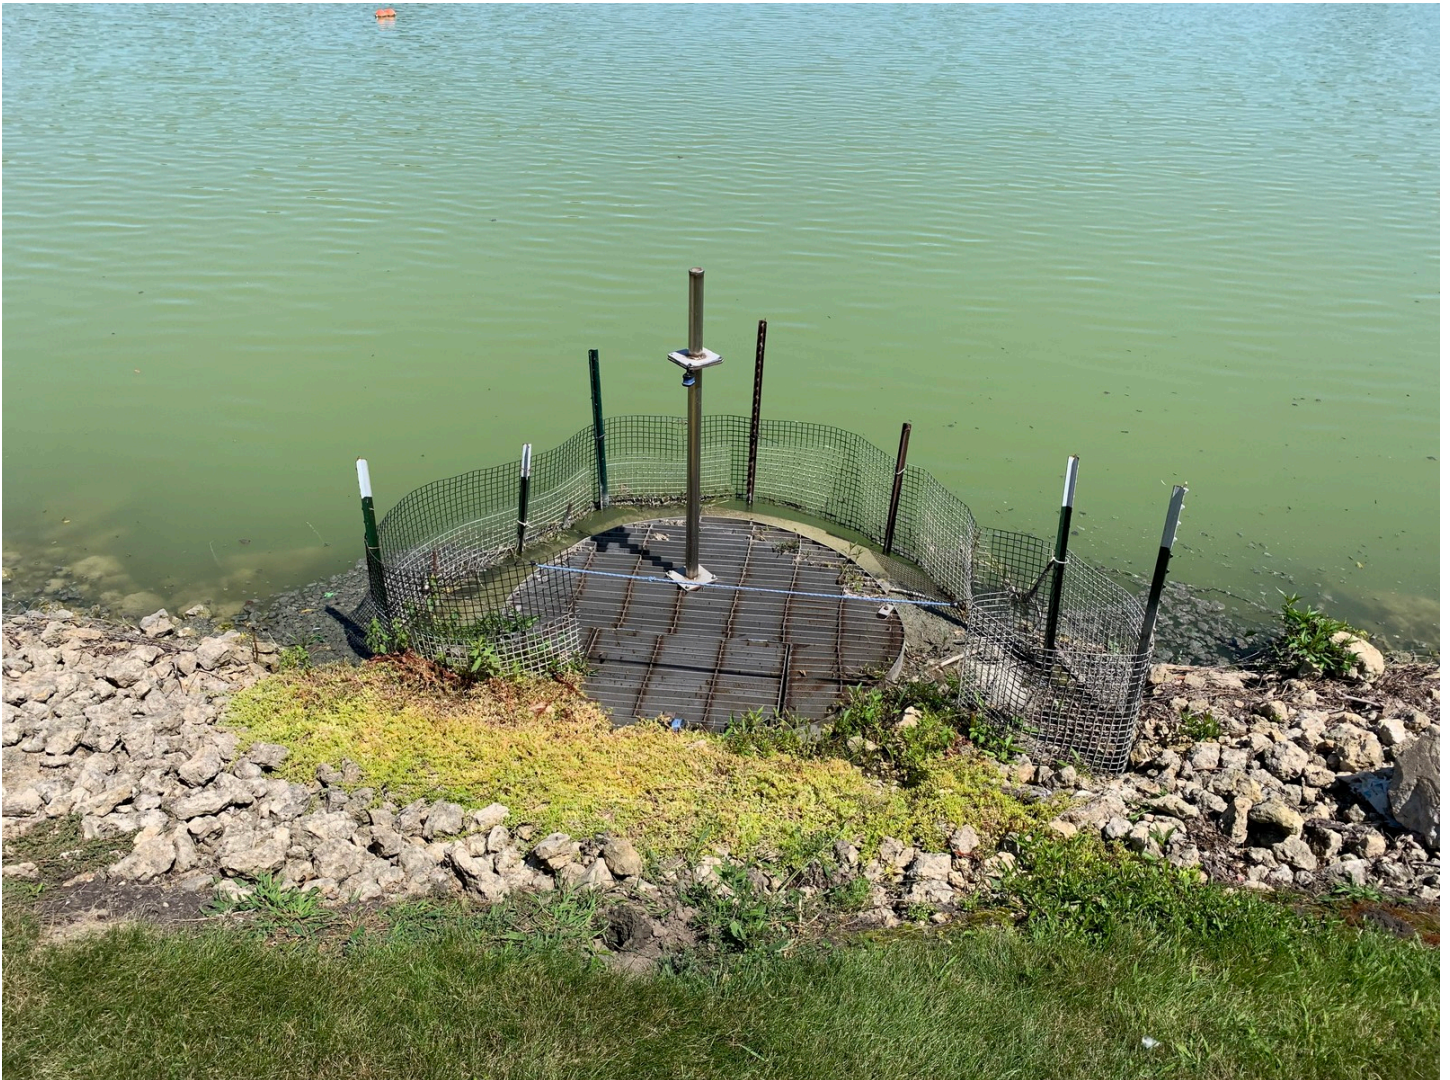
Photo #7 – Principal spillway. Good condition.

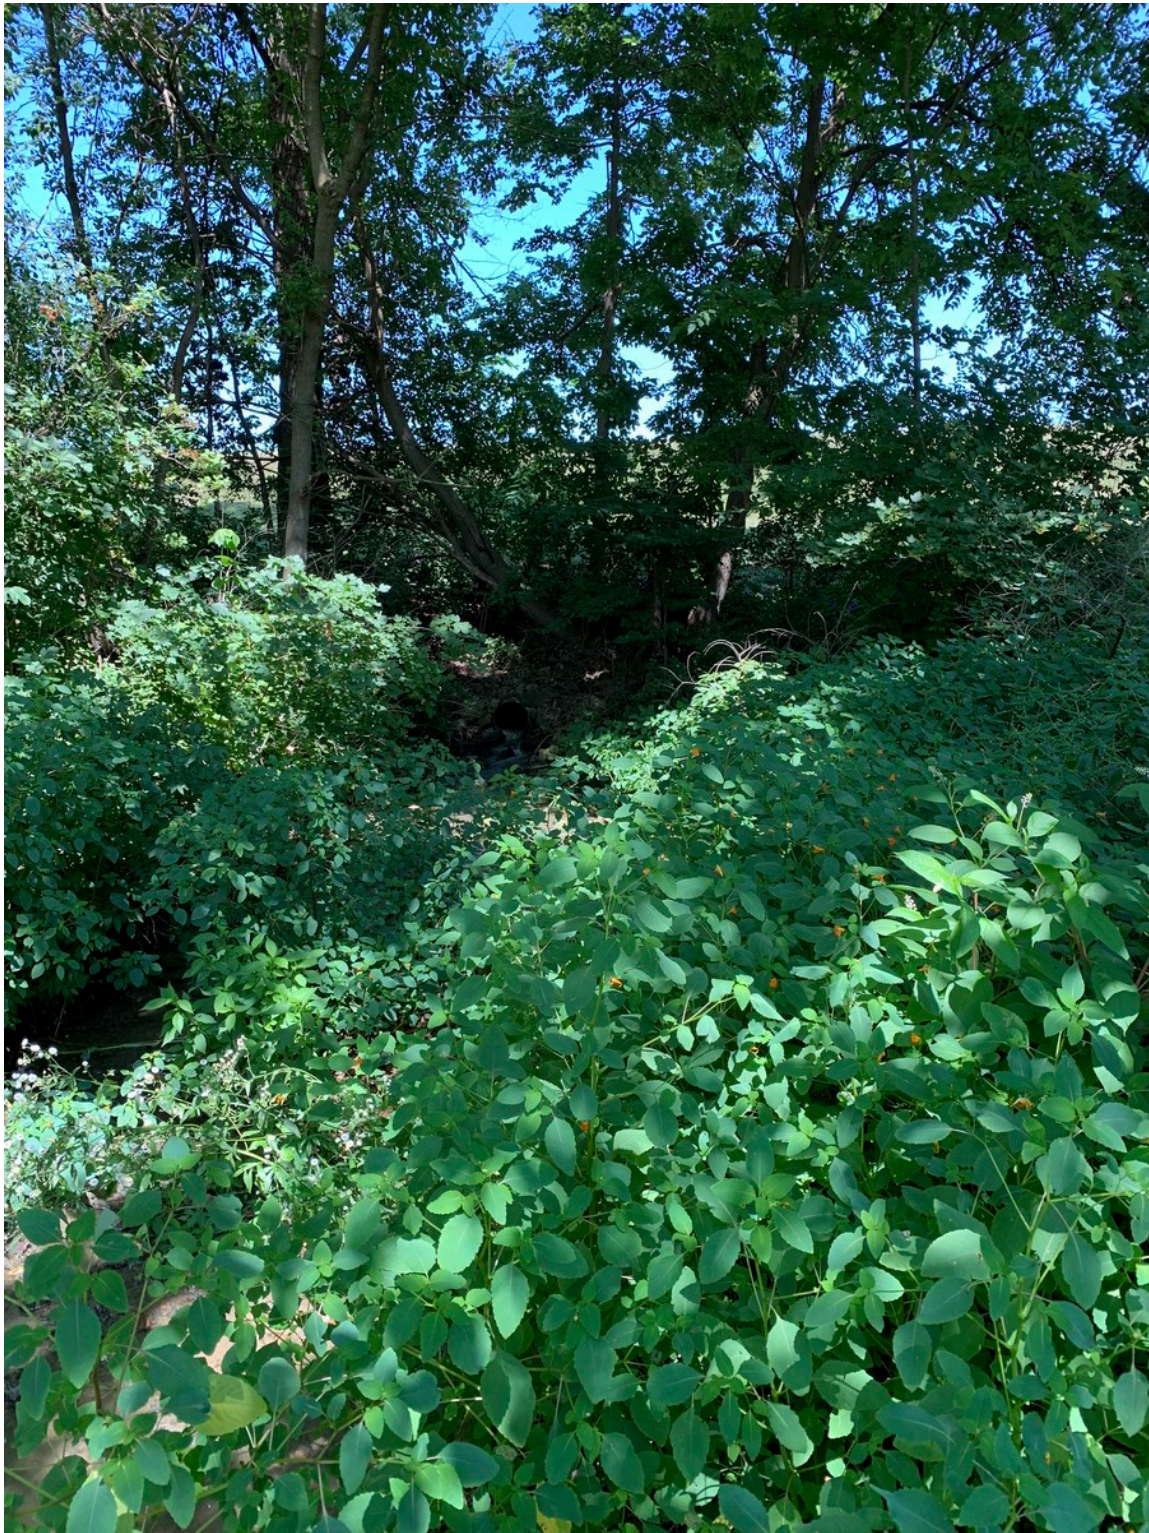
Photo #8 – Principal spillway outlet and channel.

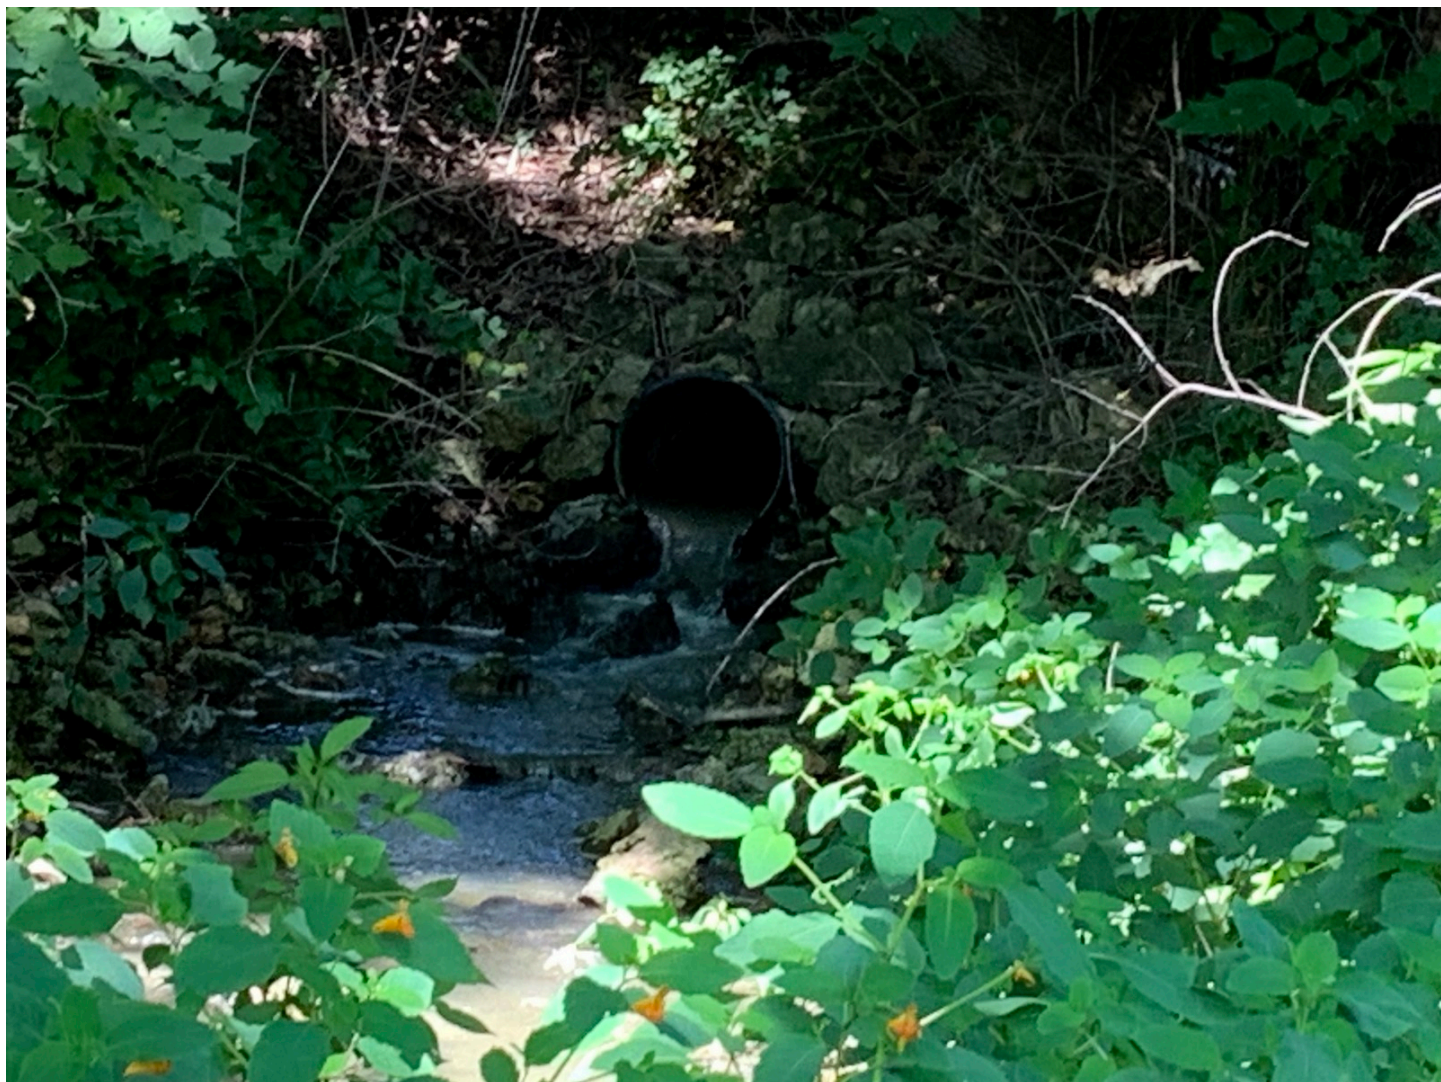
Photo #9 – Principal spillway outlet pipe.

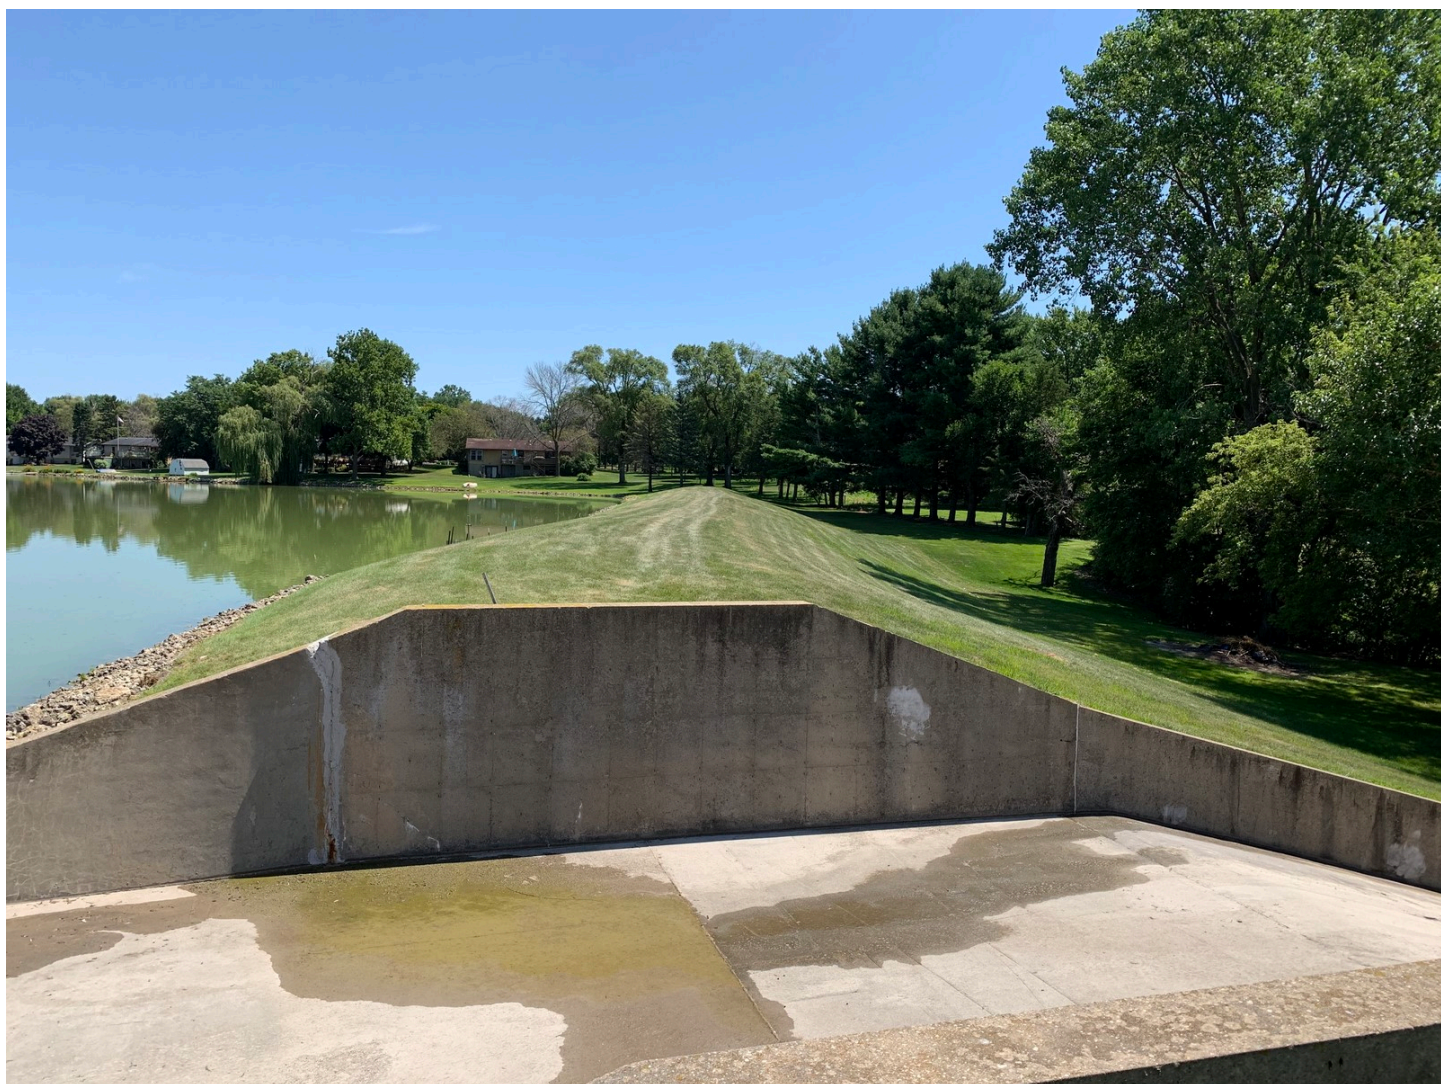
Photo #10 – Dam looking east. Good condition.

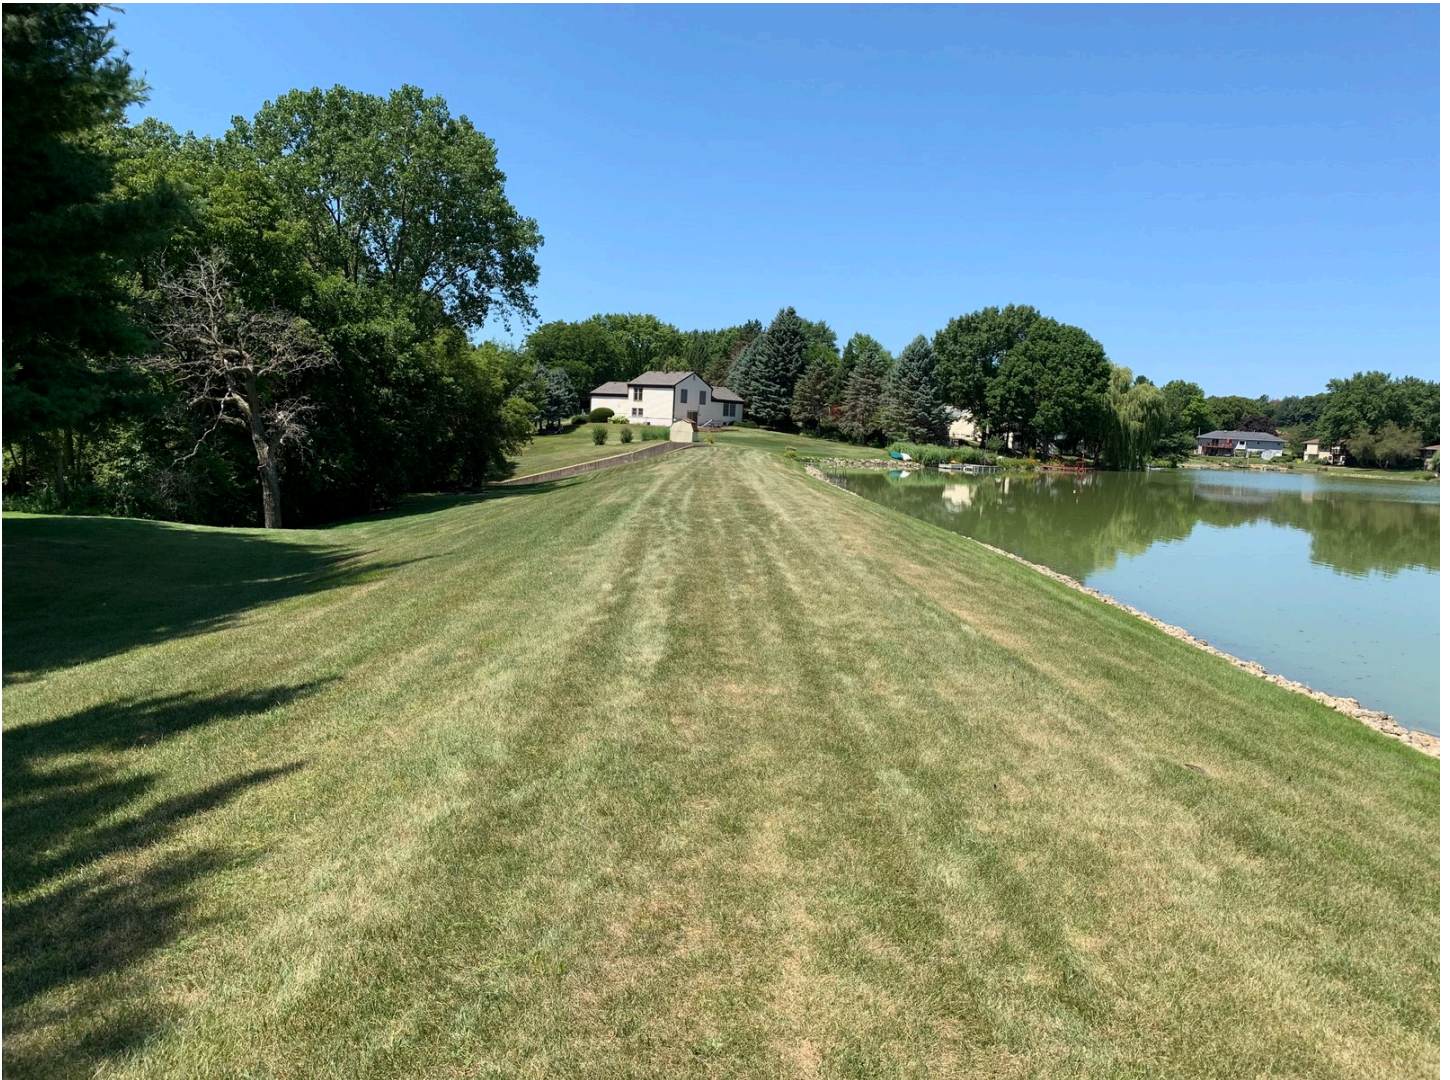
Photo #11 – Dam looking west. Good condition.

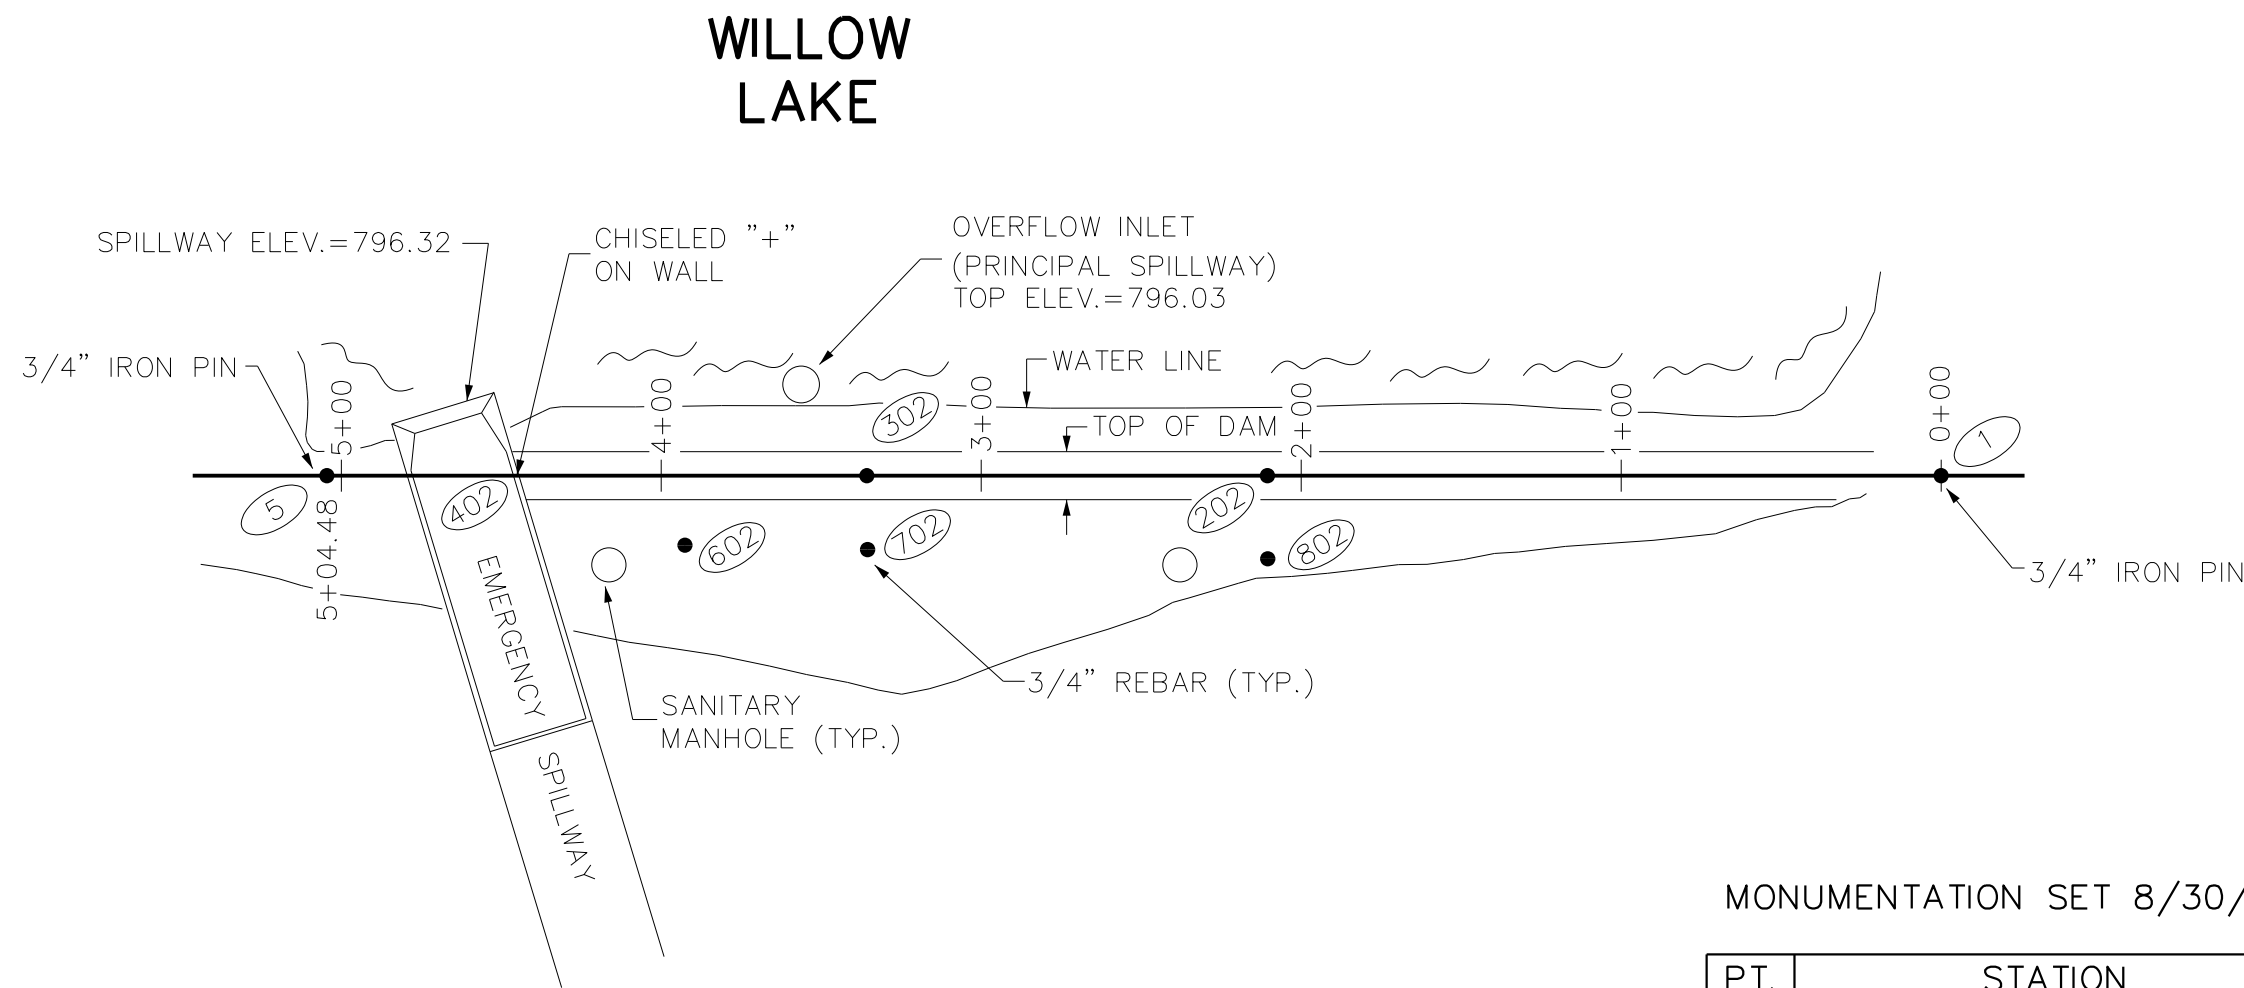
WILLOW LAKE DAM CONTROL MONUMENTATION – SKETCH

ITEM	CONDITION CODE	DEFICIENCIES	RECOMMENDED REMEDIAL MEASURES AND IMPLEMENTATION SCHEDULE
Surface Cracks	NE		
Vertical and Horizontal Alignment of Crest	NE	Control monumentation on the dam has been surveyed and there is no evidence of any movement - see attached survey report drawing.	
Unusual Movement or Cracking At or Beyond Toe	NE		
Sloughing or Erosion of Embankment and Abutment Slopes	NE		
Upstream Face Slope Protection	NE		
Seepage	NE		
Filter and Filter Drains	NE
