Storm Damage to Catchment Ponds, June 2018.

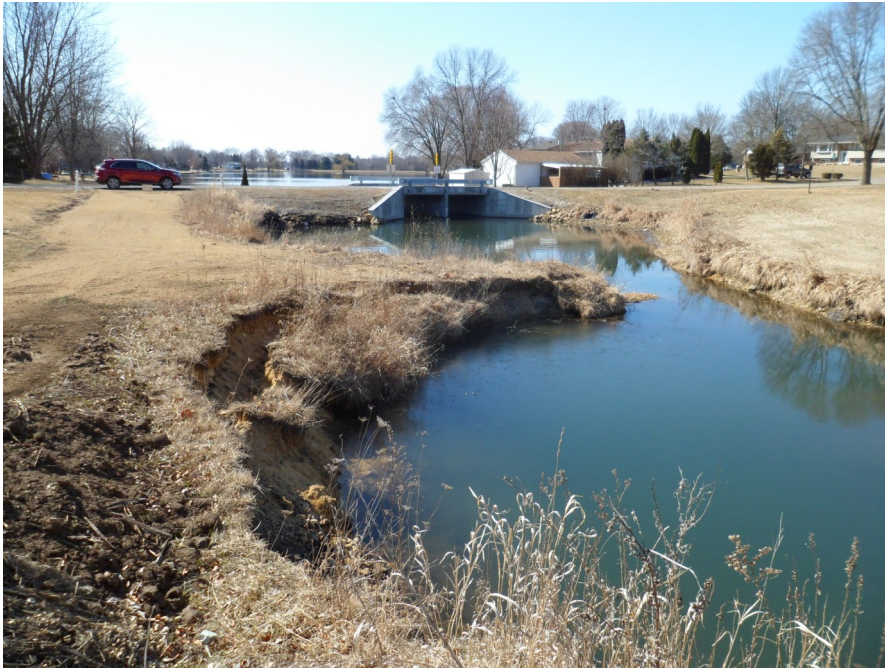
North Catchment, Pond East wall ~ Partial collapse.

The ponds are fed by a stream from the north. This stream has changed course as a result of material deposited in its bed. The rapid inflow of water scoured the east bank of the upper (northern) pond. Part of the east bank collapsed.

This bank has been cleaned and large rock placed along the surface.

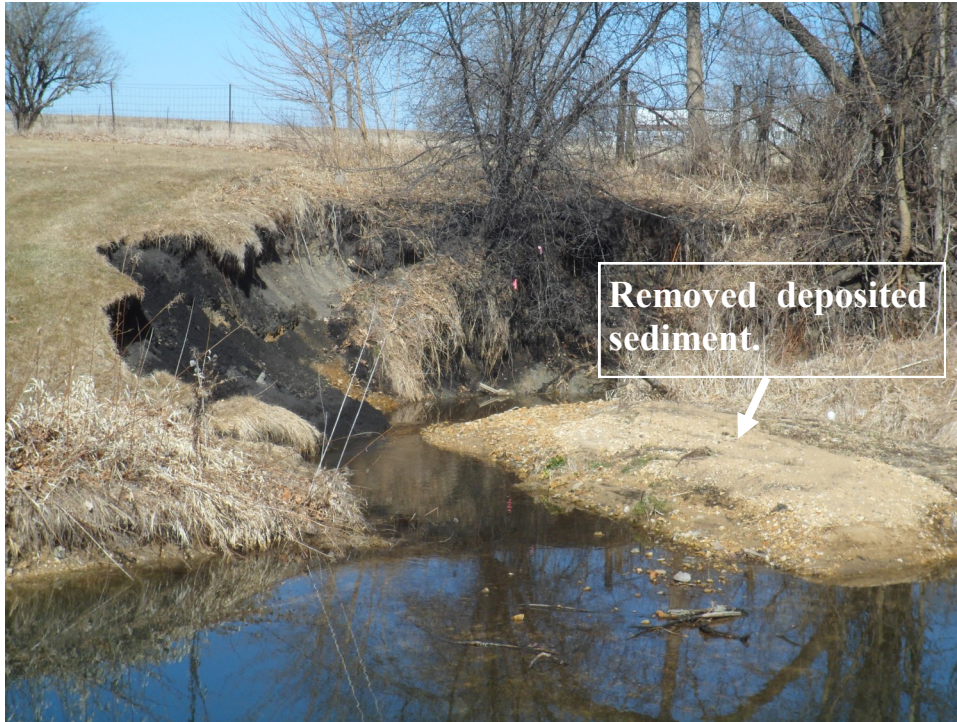
Before repair. Feeder stream, partial collapse of west bank. The stream had changed course and deposited sediment. When the stream level was high the sediment deflected the water flow against the west bank causing the collapse.

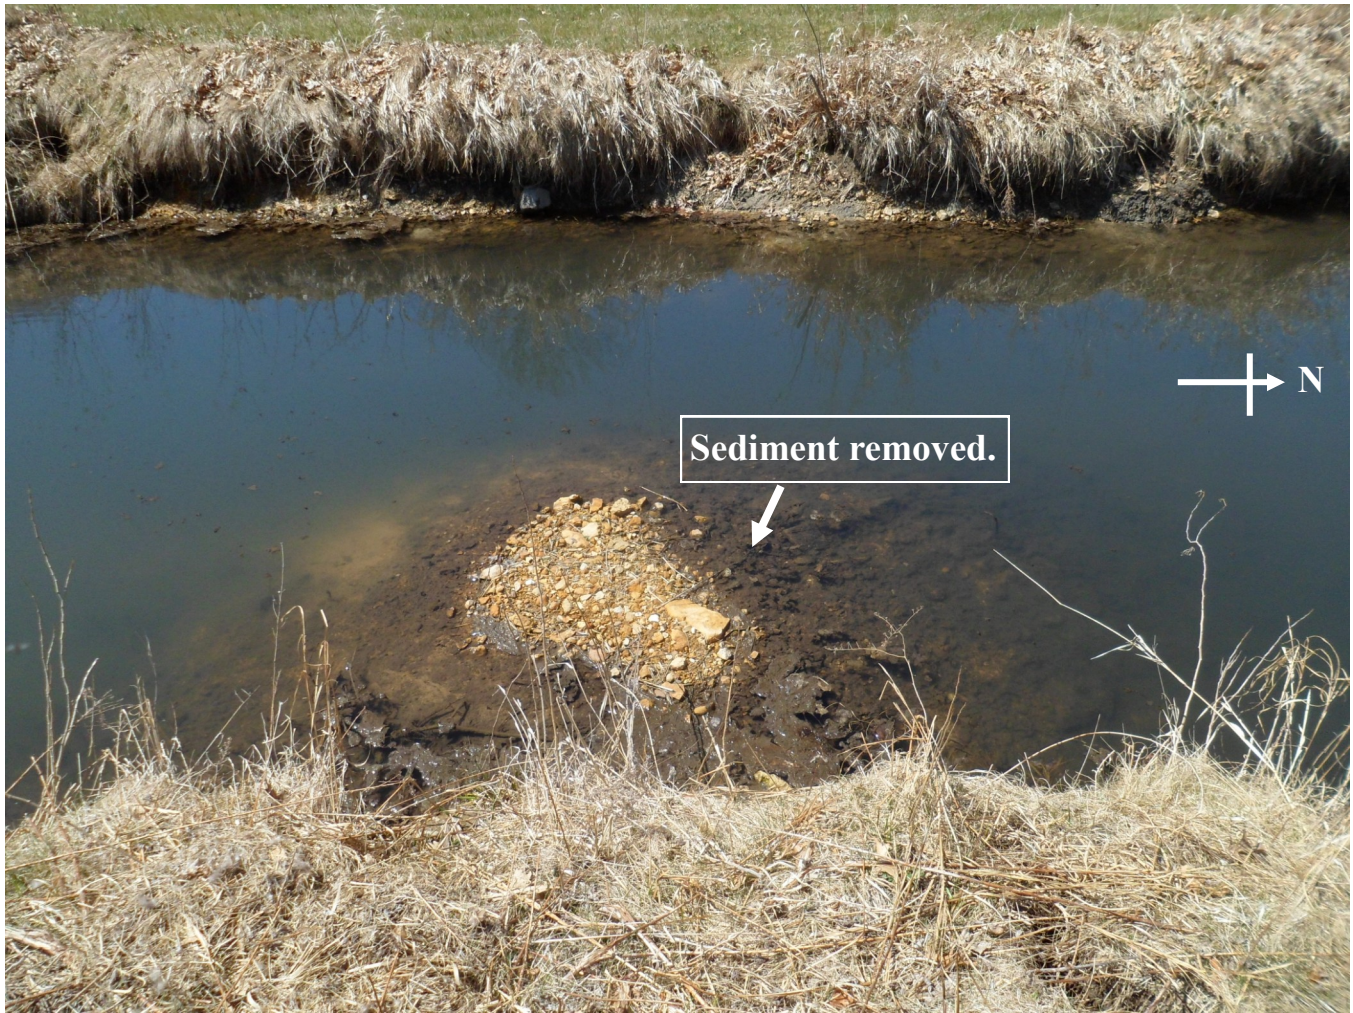
The two catchment ponds are separated by a narrow channel thus forming a figure 8. The upper pond is to the right (north). Water enters the upper pond from the narrow stream, slows down and deposits some sediment. Water flows through the separating choke point, gaining velocity, into the large lower pond. Again its flow slows and deposits more of the sediment.. The choke point is both narrow in width and more shallow than either catchment pond. Sediment was removed from the choke point.
