**PROJECT TO RESURFACE THE FLOOR OF
THE CONCRETE SPILLWAY
(August 2008.)**

The first two pages document the condition of the spillway prior to starting work.

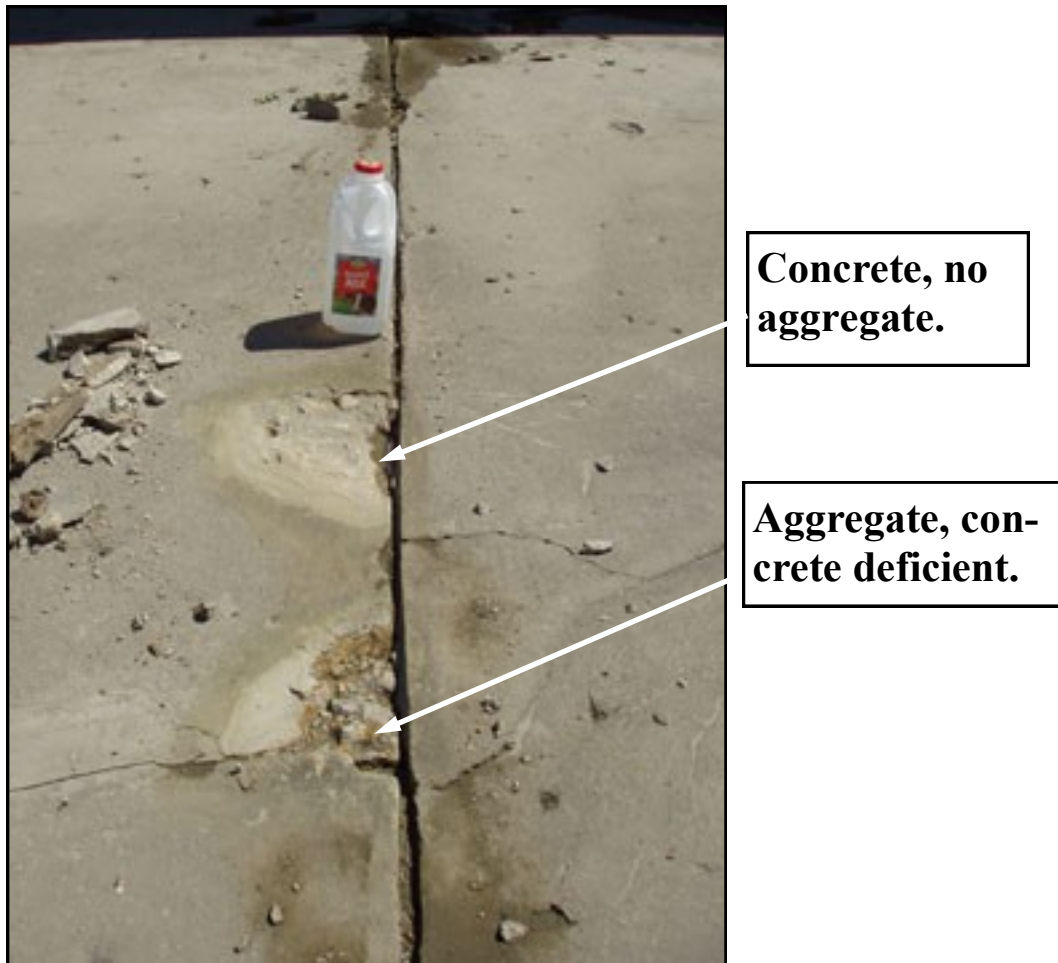
Look at the two adjacent ‘holes’. The upper one appears to be all concrete, no aggregate. The lower one, slightly deeper, shows the under layer is heavy in limestone aggregate. Either the first pour was almost all aggregate, concrete deficient, or was not mixed properly. Limestone is porous, a very bad choice for this climate. The result, water penetration and ice cracking.

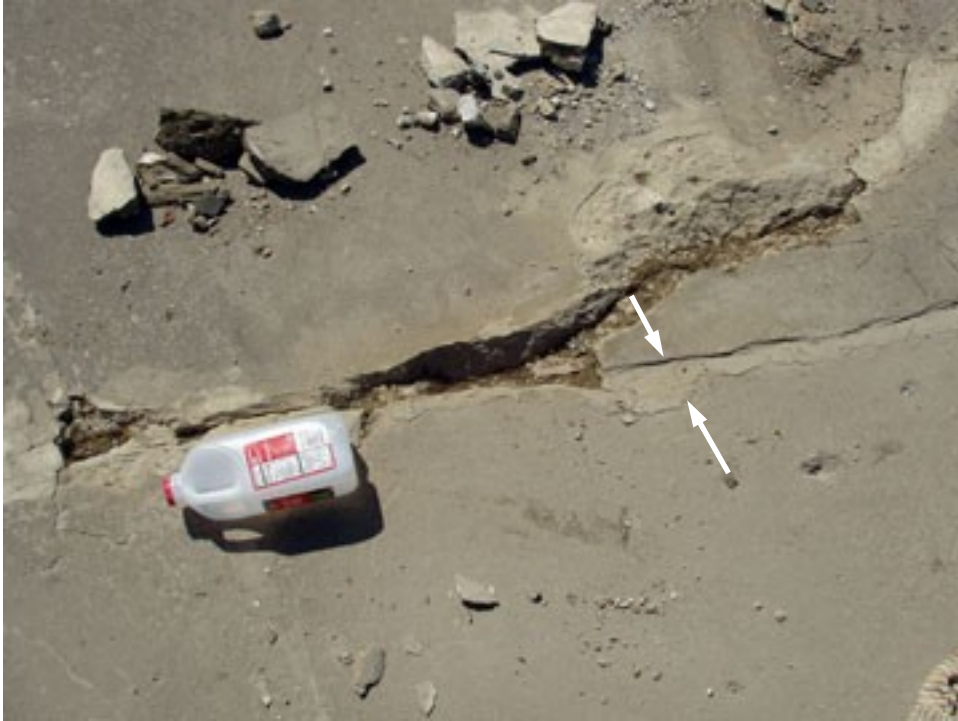
This crack was professionally filled, but is separating from the sides.

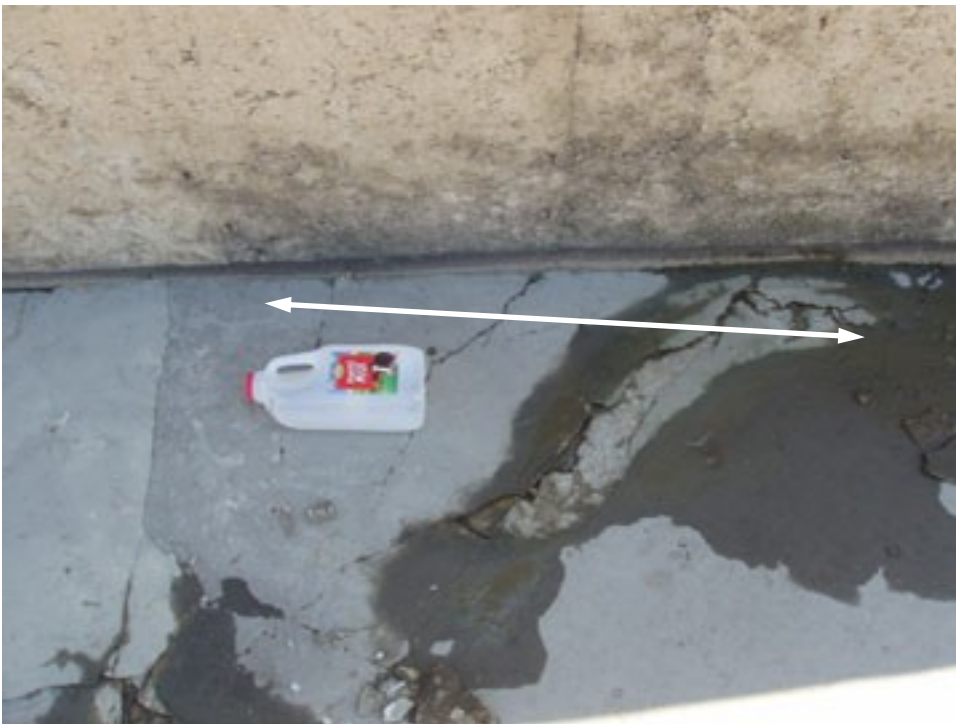
This five foot 'hollow' section was removed.

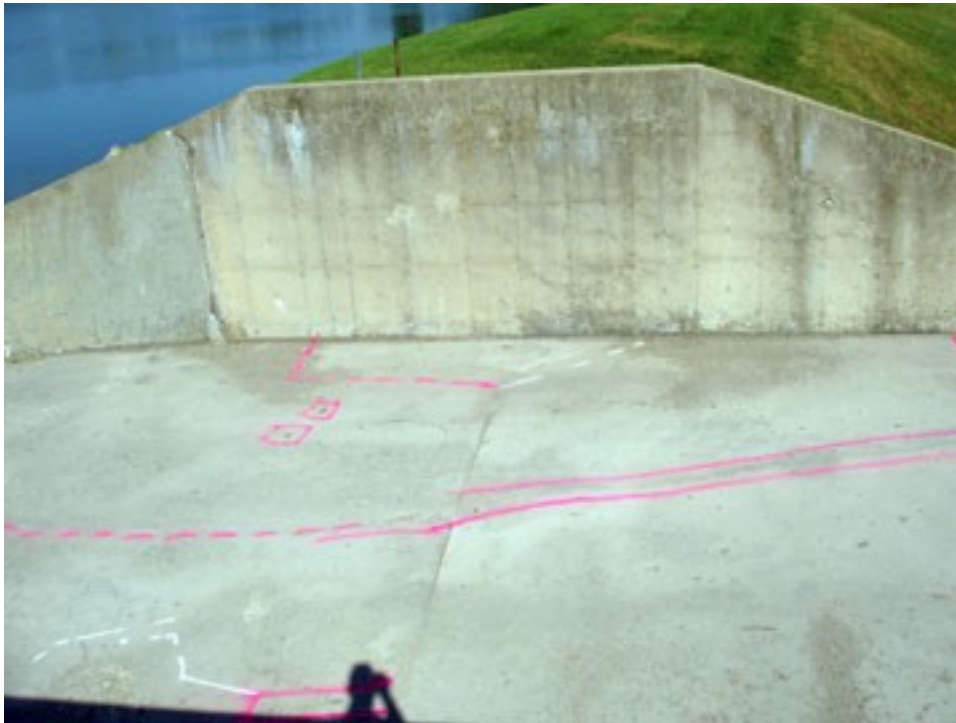
Areas of the existing dam floor were marked for removal.

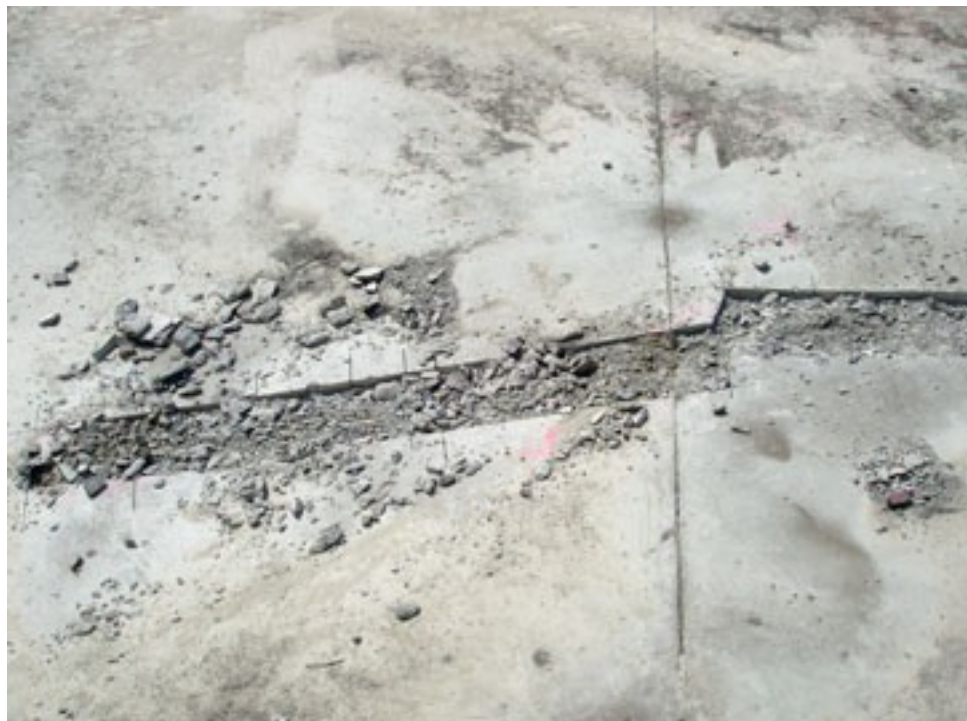
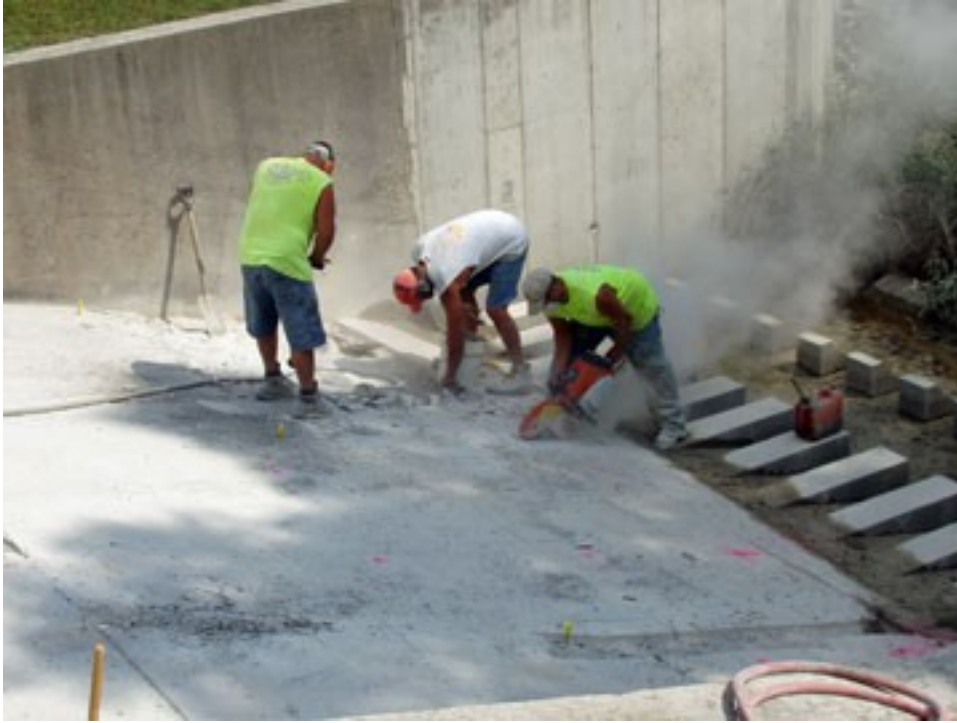
**Cut out
and filled.**

The lower section was tapered into the existing energy dissipater.
